SUMMARY

1234 Main Street Addy WA 99101

Buyer Name
02/27/2023 9:00AM

Mathew Blaha
 WA License # 22014122, InterNACHI CPI
 #21120501, CCPIA # 000923
 Built on a Rock Inspections
 (509)992-9716
mathew@builtinarockinspections.com

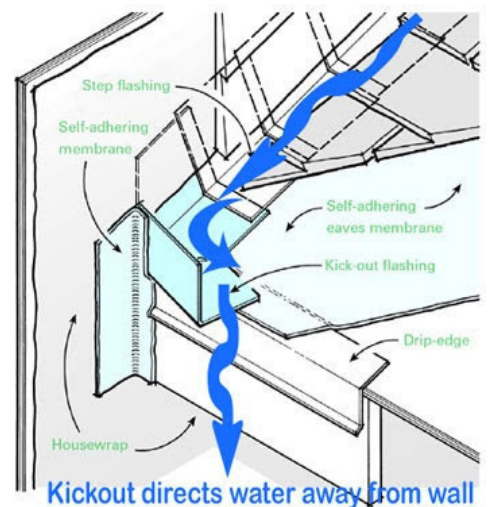
4.4.1 Roof Flashings

KICKOUT - MISSING

Kickout flashing was not present in area(s) where guttering and/or fascia abutted a sidewall. The installation of kickout flashing is recommended to be performed by a roofing contractor at any areas where gutters or fascia meet a sidewall, preventing rain water from infiltrating between the end of the gutter/fascia and the wall. Hidden damage may exist in areas where kickout flashing is missing and this should be investigated during the installation of kickout flashing.

Recommendation
 Contact a qualified roofing professional.

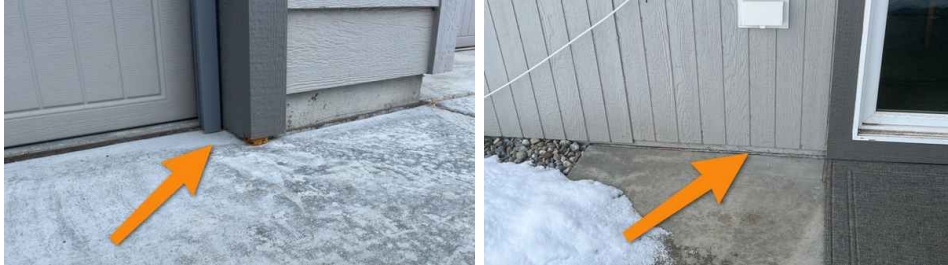
5.2.1 Walls/Cladding

GENERAL - SIDING TO GRADE CLEARANCE INADEQUATE

Marginal Defect

Inadequate siding clearance was present. Siding is recommended to have anywhere from 2 - 6 inches of clearance from roof surfaces, from grade and/or from masonry surfaces. Modifications to achieve the proper clearance is recommended by a siding contractor.

Contact a qualified siding specialist.

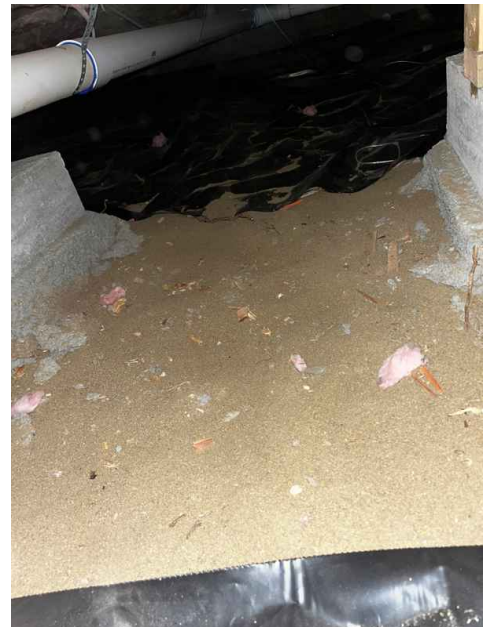
7.9.1 Ground Cover/Vapor Barrier

VAPOR BARRIER - GAPS

Marginal Defect

There were gaps present in the vapor barrier. Full coverage of the vapor barrier, eliminating any visible dirt, is recommended to minimize moisture, humidity, and possible condensation in the crawl space. Repairs to the vapor barrier are recommended as needed for full coverage by a qualified person.

Contact a qualified professional.

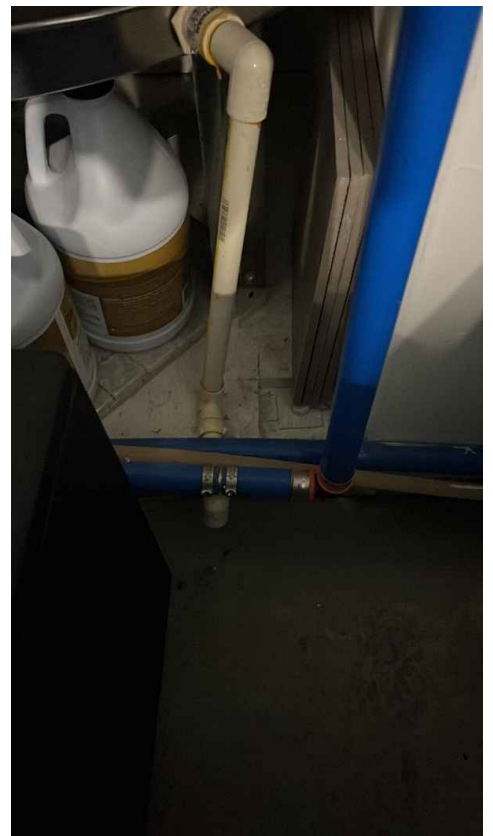
14.1.2 Water Heater Condition

DRAIN PAN - DRAIN PIPE NOT RAN TO EXTERIOR

Marginal Defect

The drain pipe for the water heater drain pan did not run to the exterior of the home. Current building standards require drain pan drain pipes to run to the exterior of the home and be between 6 - 24" above grade. Repairs to properly terminate the drain pipe is recommended to be performed by a qualified contractor.

Contact a qualified professional.

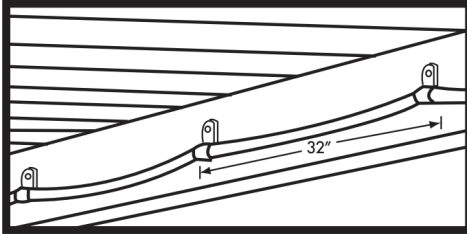
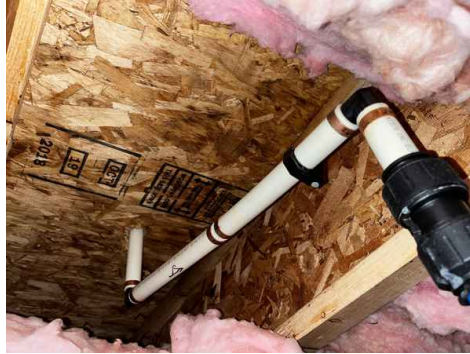
15.4.1 Water Pipes

PEX - INADEQUATE SUPPORT

Marginal Defect

The PEX water pipes were inadequately supported in areas. PEX is recommended to be supported every 32" on horizontal runs. The installation of proper support is recommended to be conducted by a licensed plumber.

Contact a qualified plumbing contractor.
